Damage detection in a composite wind turbine blade using 3D scanning laser vibrometry

Ryan Marks¹, Clare Gillam¹, Alastair Clarke¹, Joe Armstrong² and Rhys Pullin¹

Abstract

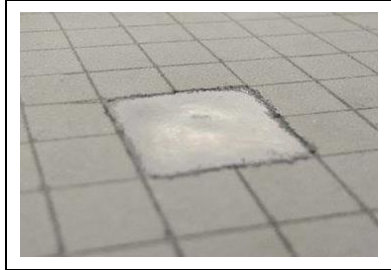
The blade was secured at the base to a steel stanchion and supported on both sides of the area of investigation. The blade was impacted using a 20mm radius impactor with impact energy of 10 Joules in an INSTRON dynatup 9250HV impact test machine. The impact caused BVID on the surface as shown in Figure 3. The impact was representative of a hail stone impact.

Figure 3. BVID on the turbine blade after being impacted. The retro-reflective beads have been removed around the impact site for clarity.

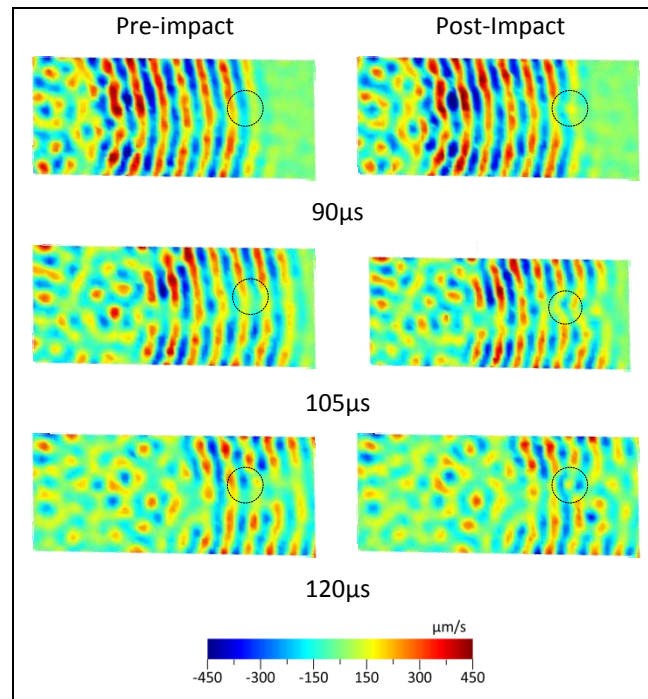
As the A_0 Lamb mode is mostly out-of-plane, this component was isolated and plotted separately for clarity as shown in Figure 6. It is evident that the out-of-plane component of the Lamb wave interacts with the damage causing a disruption in the wave front. This suggests that the unintelligibility of the interaction of the A_0 mode with the damage in the resultant magnitude plots in Figure 4 and Figure 5 is mostly caused by noise from the in-plane components.

Figure 6. 100kHz excitation out-of-plane component highlighting the Lamb wave interaction with the impact damage

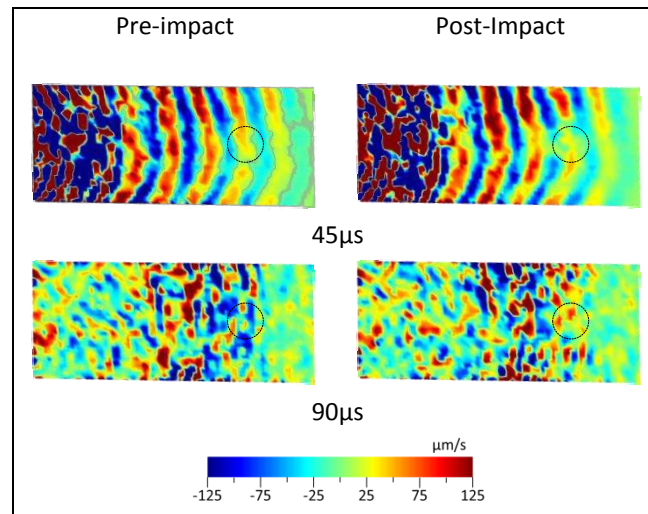
Figure 9. 200kHz excitation out-of-plane component highlighting the Lamb wave interaction with the impact damage

The results at $45\mu\text{s}$ show that there is possibly some interaction with the S_0 mode. This may be indicated in the post-impact results where there is a significantly lower amplitude than in the pre-impact results due to the presence of the impact damage. This can be justified by the shorter wavelength of the 200kHz excitation S_0 mode compared to that of the 100kHz excitation. However, there appears to be no disruption in the wave front to the right of the impact site which also suggest that there is limited interaction with the impact damage. It is therefore not conclusively possible to determine the presence of the impact damage using the S_0 mode from the 200kHz excitation by visual observation alone.

It is difficult to determine from these results whether the A_0 mode is influenced by the presence of the damage as demonstrated at $90\mu\text{s}$. It is apparent there is a difference in the results and it could be argued that the reduction in amplitude in the post-impact results was due to the presence of the damage. However, due to the high levels of disturbance in the wave front this is also by no means conclusive.

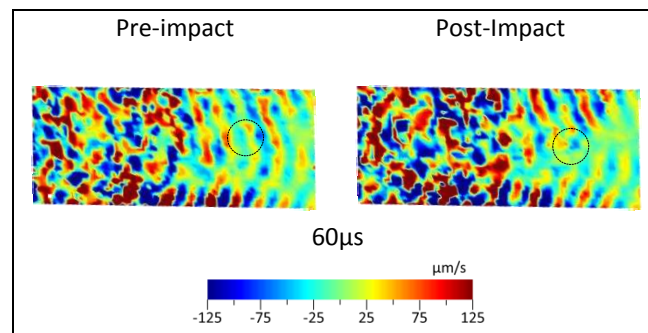
Figure 12. 300kHz excitation out-of-plane component highlighting the Lamb wave interaction with the impact damage

As with the 200kHz excitation, the S_0 mode interacts with the damage. This is shown in the post-impact results by a fringe of low amplitude to the right of the impact damage. However, as also with the 200kHz excitation, due to the high levels of disturbance in the wave it is not possible to determine A_0 mode interaction with the damage.

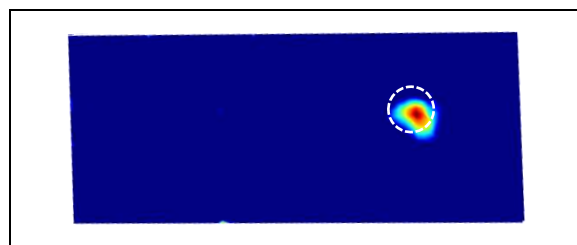
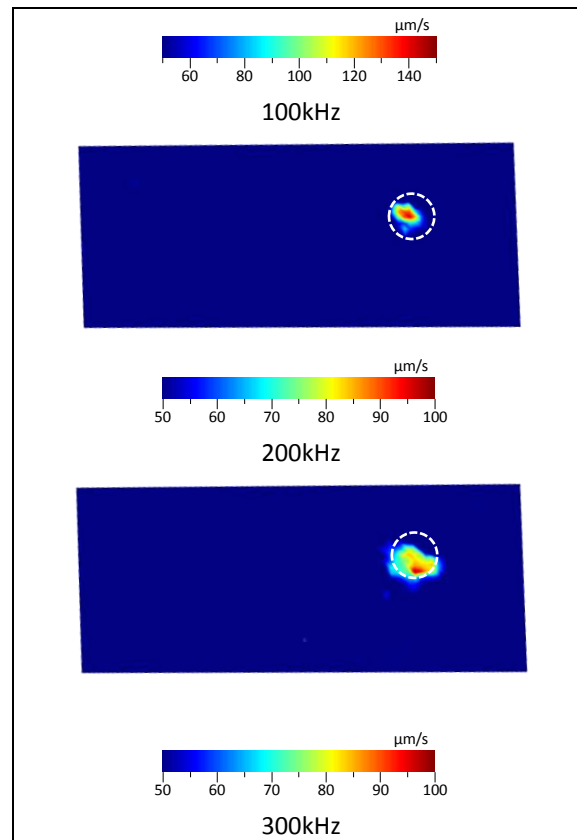
Figure 13. RMS baseline subtraction analysis of the out-of-plane component of the Lamb modes

For each excitation frequency the impact site has been clearly identified by this technique. The peak RMS values for the 100kHz excitation are greater than those for the 200kHz and 300kHz excitations. This is because of the lower attenuation of the lower frequency. The RMS values the plate area outside of the impact site are not zero. This is because of small differences in experimental setup between the pre and post impact vibrometry scans. This has resulted in a small phase difference which when subtracted results in low amplitude signals being produced. In addition to this, low amplitude reflections result due to Lamb wave interaction with the damage and hence cause an additional change in signal.

measurements across the peak for each excitation frequency found the average length of the area affected by the presence of the damage to be 12.6mm, 7.8mm and 14.9mm, for the 100kHz, 200kHz and 300kHz results respectively. Surprisingly the average length of the area affected by the presence of the damage increases from the 200kHz excitation results to the 300kHz excitation results as the reduction in wavelength should be more sensitive to the impact damage.

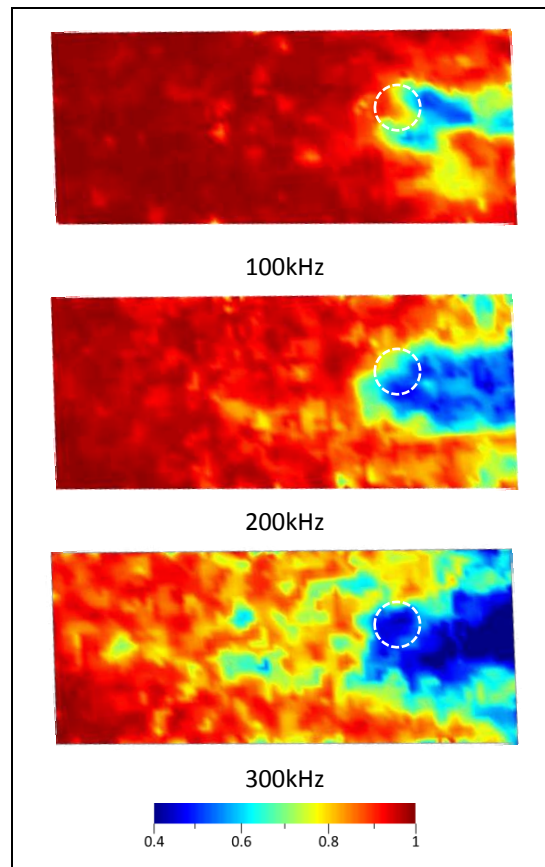
Figure 14. Out-of-plane cross-correlation coefficient results

It is evident that the Lamb wave interaction with the impact damage significantly alters the waveform when compared to the pre-impact waveforms.

The results from the 100kHz excitation show that there is little difference in waveform in-front (left hand side of Figure 14) of the impact damage. There is a significant, localised reduction in correlation downstream (right) of the impact damage. There is an increased area of lower correlation behind the impact damage in the results from the 200kHz excitation. In addition to this, there is also a minor reduction in correlation in front of the impact damage. The 300kHz results show an increased area of lower correlation behind the impact damage when compared to the 200kHz results as well as reduced correlation in front.

The increased area of lower correlation demonstrates that higher frequency Lamb waves are more sensitive to interaction with damage due to their smaller wavelength. At the higher frequencies there is also a reduction in correlation in front of the impact damage. This is most likely due to reflections from the damage.

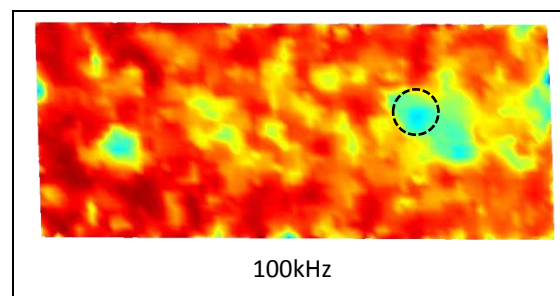
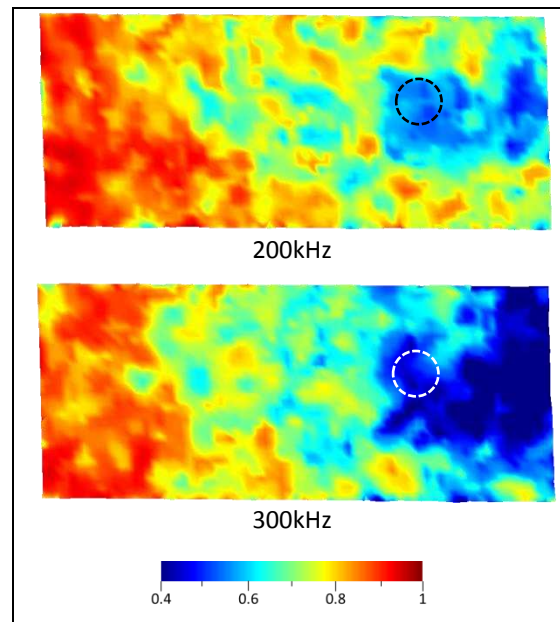
Figure 15. In-plane cross-correlation coefficient results

It is apparent that the propagation of the in-plane component of the Lamb wave is affected by the presence of the impact damage. The 100kHz results clearly indicate a difference in the two Lamb wave signals at the of the impact damage. Comparing this with the out-of-plane results it is evident that there is less reduction in cross-correlation coefficient in this region.

Unlike the out-of-plane results, there is a significant reduction in cross-correlation coefficient over a much larger region of the area of investigation. This can be justified by the scattering of the in plane modes due to the microstructure. It was demonstrated by comparing the resultant magnitude plots with the out-of-plane plots for the 100kHz excitation that a significant level of noise could be attributed to the in-plane components. This is due to the random placement of the chopped fibres. In fibre composite materials the in-plane Lamb wave components are influenced by the fibre direction⁵³ therefore inhomogeneity of the fibre directions will have a more significant influence the noise on the in-plane components than the out-of-plane.

The results from the 200kHz excitation identify a region of reduced cross-correlation coefficient surrounding the impact site. The region is larger than that of the 100kHz excitation and is similar to that observed in the out-of-plane results. This can be attributed to the shorter wavelength of the higher frequency excitation. Like the 100kHz excitation, there is a region of reduced cross-correlation coefficient

upstream of the impact site. This suggests that the in-plane component of the Lamb wave is partially reflected by the presence of the impact damage which is not possible to determine by studying the time-domain plots alone.

The results from the 300kHz excitation show a large region of the area of investigation where there is a significant reduction in cross-correlation coefficient. Like the 200kHz excitation, there is a larger area of reduced cross-correlation coefficient to the left of the impact site than that observed in the out-of-plane results. This would suggest that more of the in-plane components were reflected by the presence of the impact damage than the out-of-plane components.

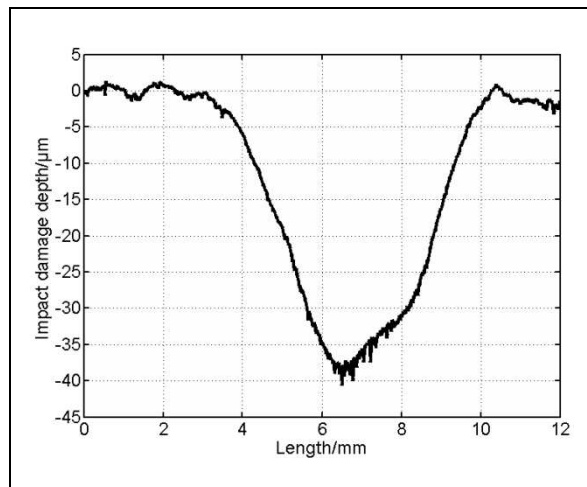
Figure 17. Surface profile of the BVID showing the length and maximum depth of the indentation created.

The depth of the impact damage on the outer face was significantly lower than that of 0.25mm which had been suggested as a quantifiable level for BVID. When inspecting the removed section it was only possible to see the damage at certain angles of viewing in well-lit conditions.

Comparing the measurement of the length of the impact site with the dimension determined from the 200kHz RMS baseline subtraction technique, there is only a 7% difference demonstrating that this Lamb wave analysis technique has potential for indicating the scale of BVID. Indeed, all three excitation frequencies identified dimensions (of the region of significant difference in waveform) which are of similar magnitude.

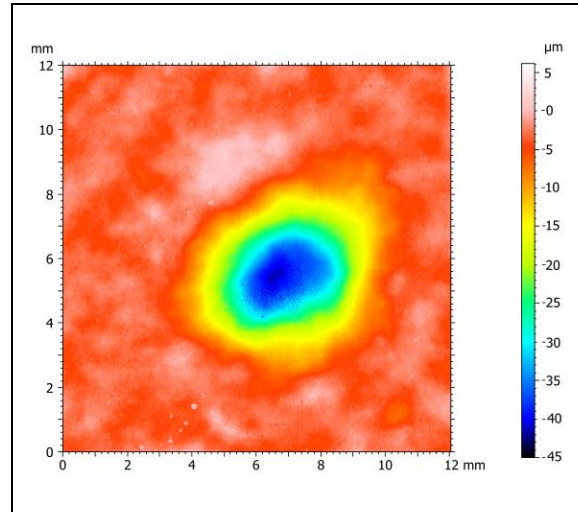
Figure 18. 3D Talysurf scan - Plan view of the BVID.

The 3D measurement shows a clear indentation caused by the impact damage. Though the maximum depth of the indent was found to be 40 μm , the 3D measurement shows that only an approximately circular area of around 2mm diameter of the indentation is of this depth. This measurement however does confirm that there was no additional damage caused by the impact damage on the outer surface of the blade.

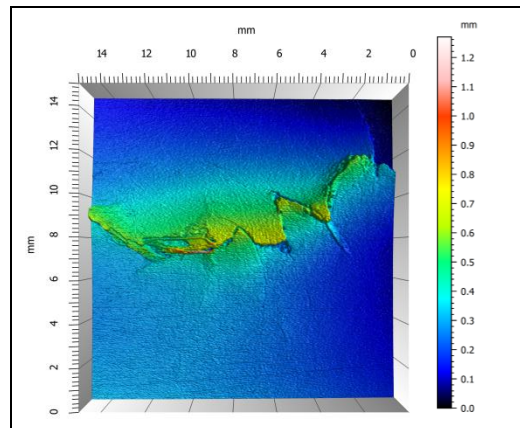
Figure 19. White light interferometry measurement of the crack on the inner face

These results show that the impact resulted in displacing material by approximately 0.9mm along the length of the crack which is photographed in Figure 16. This is significant damage which would affect the structural performance of an operational wind turbine blade.

Comparing the scale and location of the crack with the results from the 300kHz baseline subtraction it is possible that the larger area of increased RMS value was due to the presence of the crack, although this observation is by no means conclusive. As the crack ran in the same direction as the propagating wave, it would have little effect on the wave. It is possible however that shorter wavelength of the 300kHz excitation did interact with the damage.
